# Ingham Spring Dam Removal Study

November 2004

**Prepared For:**  
Bucks County Chapter of  
Trout Unlimited

F. X. Browne, Inc.  
Engineers • Planners • Scientists  
[info@fxbrowne.com](mailto:info@fxbrowne.com) • [www.fxbrowne.com](http://www.fxbrowne.com)  
800-220-2022

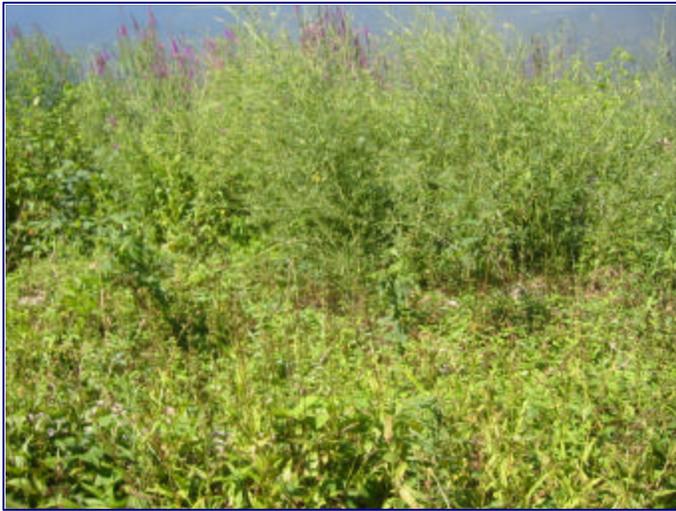
*Upstream slope.* The upstream slope appears to be in good condition. Most of the upstream slope is covered with unmowed herbaceous vegetation. There are no significant trees growing on the upstream slope. No sloughing, subsidences or depressions were observed along the upstream slope. Occasional areas of loosely placed rip-rap slope protection were observed along the upstream slope. No surface cracks, toe movement, or other unusual conditions were observed along the upstream slope. No animal burrows were observed.

Figure 7. Unmowed herbaceous vegetation growing on the upstream slope

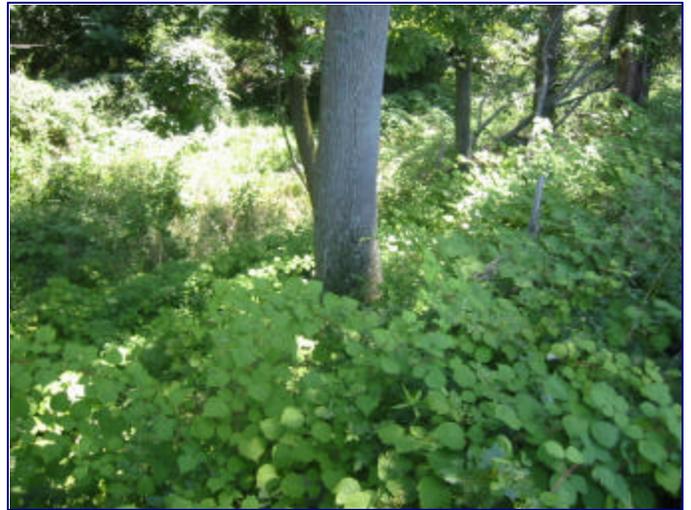
*Downstream slope.* The downstream slope is characterized by significant tree growth, which can cause serious problems for dam stability. Forty-seven >6 in. caliper trees were observed on the downstream slope. Many of the trees are mature specimens of over 18 in. caliper. No sloughing, subsidence, or depressions were observed on the downstream slope. No surface cracks or movement at the toe were observed. No seepage was observed. No animal burrows were observed.

Figure 8. Mature trees growing on the downstream slope

The visual dam inspection conducted as part of this project indicates that the integrity of the Aquetong Lake dam is severely compromised by the extensive growth of large trees along the downstream embankment. While reconstruction of the dam would likely cost close to \$1 million, the removal of the dam would likely be far less expensive and would offer the significant benefits associated with restoration of a high quality cold water fishery throughout Aquetong Creek. The results of our study suggest that a dam removal option may represent a low cost, high benefit option for the Ingham Spring Site when compared with the dam rehabilitation option currently being considered by the Township. We recommend that BCTU work with Solebury Township and the PA Fish and Boat Commission to more comprehensively evaluate the feasibility of a dam removal at the Ingham Spring site.

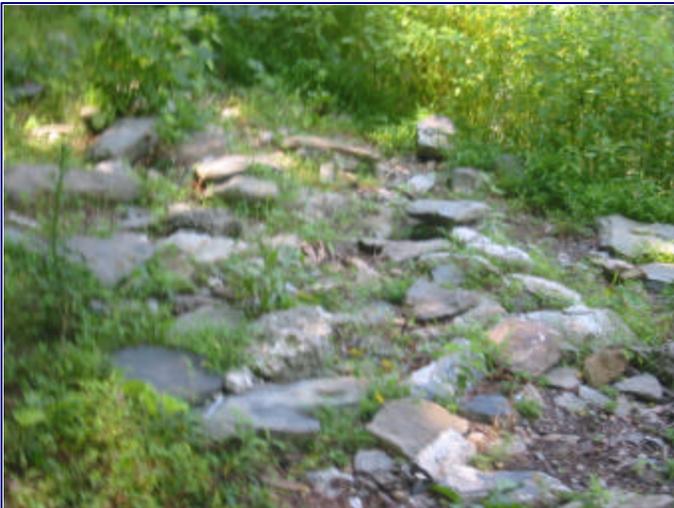
Figure 9. Rip-rap slope protection along the upstream slope

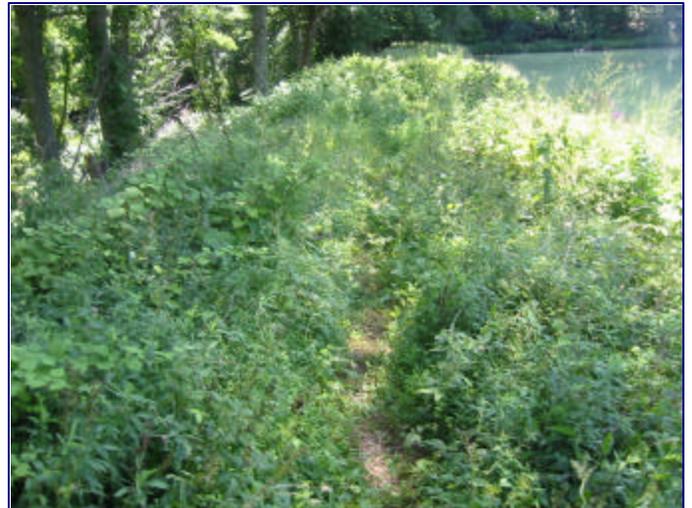
*Crest.* The dam crest appears to be in good condition and is free of major problems. The vertical alignment of the crest is flat, while the horizontal alignment was observed to have a slight bend. No surface cracks or settlement were observed along the crest.

Figure 10. Looking south along dam crest

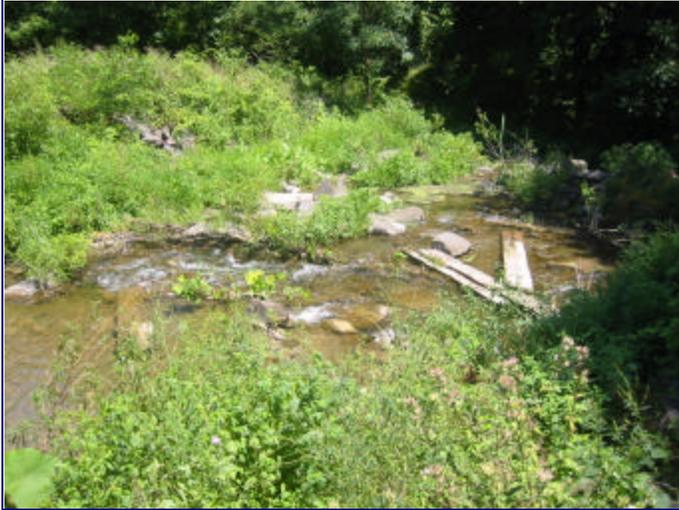
The Aquetong Lake dam is an earthen embankment dam measuring 550 feet long. The dam does not have structural abutments, outlet structures, or an external drainage system. The dam is partially breached along the northern terminus. The breach is approximately 45 feet wide and appears stable. The height of the dam increases from north to south. At the northern end of the dam, the dam height is approximately 8.5 feet, while the height of the dam at the southern terminus is approximately 28 feet. The slope of the downslope embankment is approximately 1.5(H):1(V), while the slope of the upslope embankment is approximately 3(H): 1(V). The width of the dam breast varies between 10 and 13 feet.

Figure 11. Looking north at partial breach section

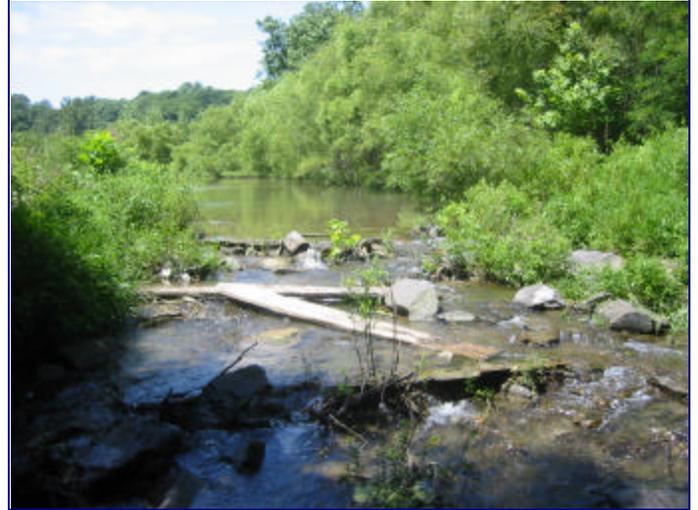
Figure 12. Looking north at partial breach section

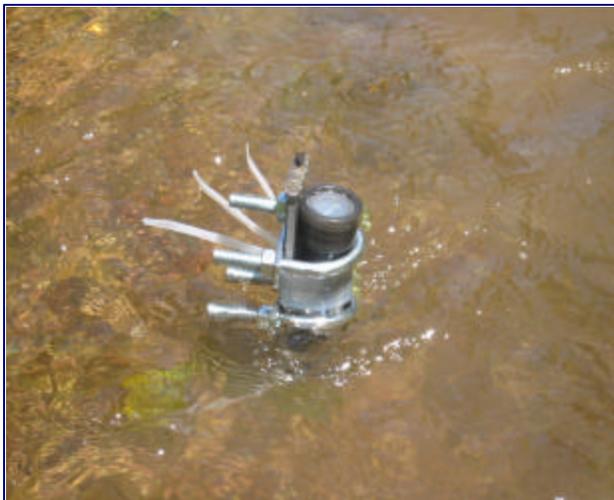
*Methods.* Continuous stream temperature monitoring was conducted at monitoring stations located immediately upstream and downstream of Aquetong Lake. Upstream and downstream stations were located in stream sections with similar water depth (approximately 1 foot) and that received direct sunlight throughout the day. HOBO® Water Temp Pro automated temperature sensors were installed at the upstream and downstream monitoring stations. Temperature data collection at both stations began at 14:00:00 hours on July 26, 2004 and ended at 14:15:00 hours on September 17, 2004. Stream temperature was recorded every fifteen minutes throughout the study period.

**Figure 13. Close up view of deployed HOBOTM Water Temp Pro automated temperature sensor.**
